Study protocol

Proximal tibia fracture

Cios Spin mobile C-arm

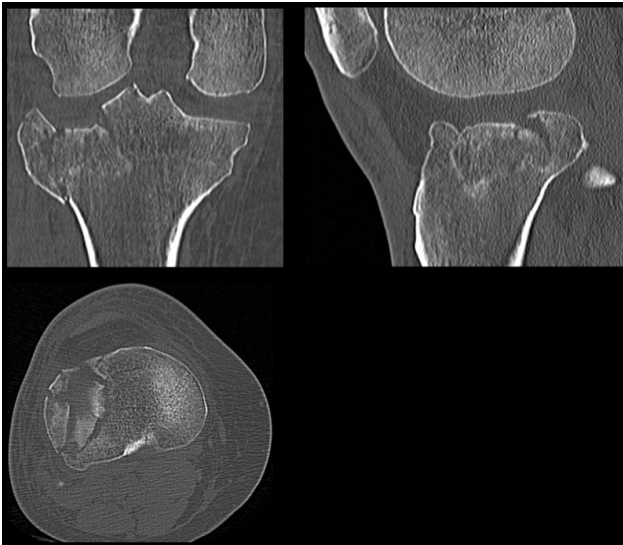
Fig. 1

Preoperative CT: coronal/sagittal/axial view of right knee joint.
Multifragmentary fracture of the tibial plateau. Impression of articular surface

Lateral fracture of the right tibia plateau type 21-B3 (Fig. 1)

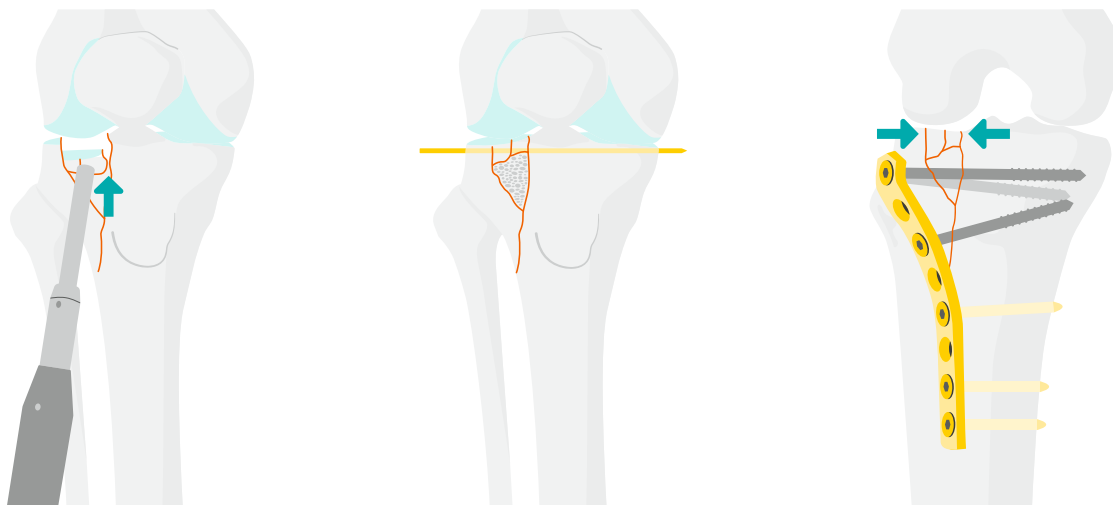
Fig. 2

ORIF – plate with angular stability

ORIF – plate with angular stability: reduction of articular surface, filling of defect or adjustment osteotomy, plate fixation (Figs. 2-6)

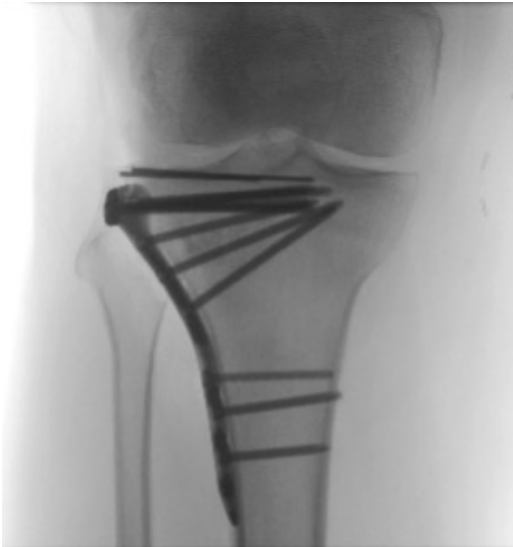
Fig. 3

AP view of right knee joint: anatomical reduction of tibia plateau alignment. Correct plate position. No intra-articular screw penetration. Good bony contrast despite metal objects

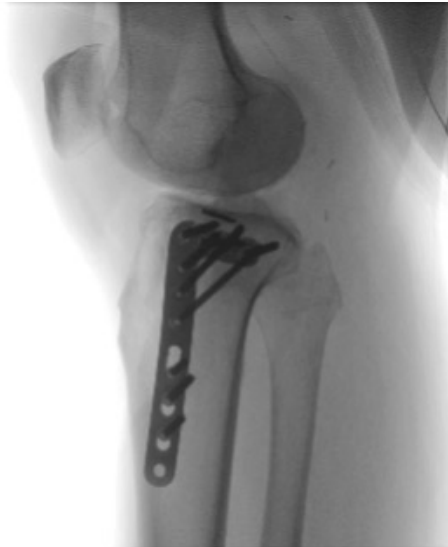
Fig. 4

Lateral view of right knee joint: correct plate position. No intra-articular fragments or screw penetration. Good field of view

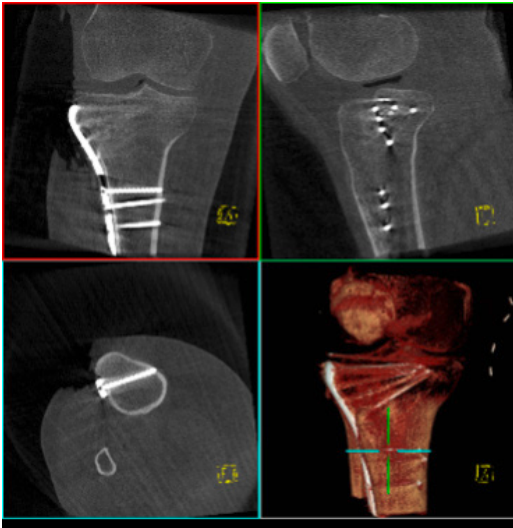
Fig. 5

3D scan of the knee joint: good bony contrast. Minor metal artifacts. Anatomical reduction of articular surface. No intra-articular fragments or screw penetration

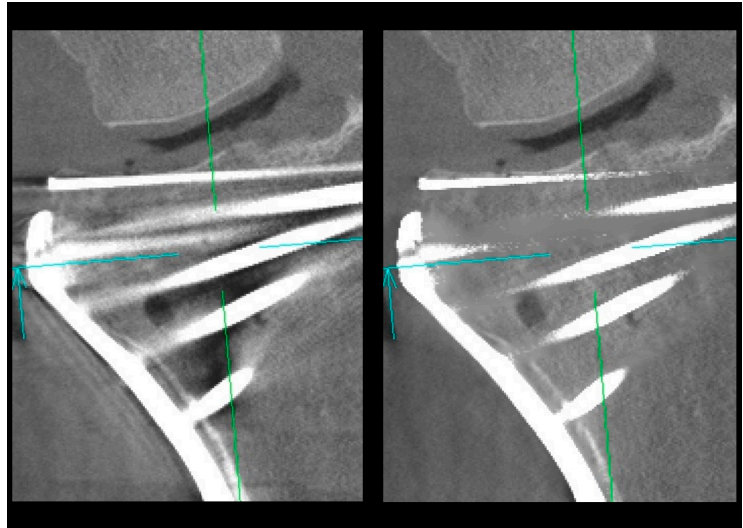
Fig. 6

3D scan of right knee joint. Before artifact reduction (left): joint surface of lateral tibia plateau cannot be clearly defined due to metal artifacts. After artifact reduction (right): joint surface of lateral tibia plateau is now clearly delimited
