# Scaphoid fracture

Multitom Rax Real3D<sup>1</sup> Hi-Res clinical case  
University Hospital Wuerzburg, Germany

# Clinical background and indication for Multitom Rax Real3D<sup>1</sup> Hi-Res examination

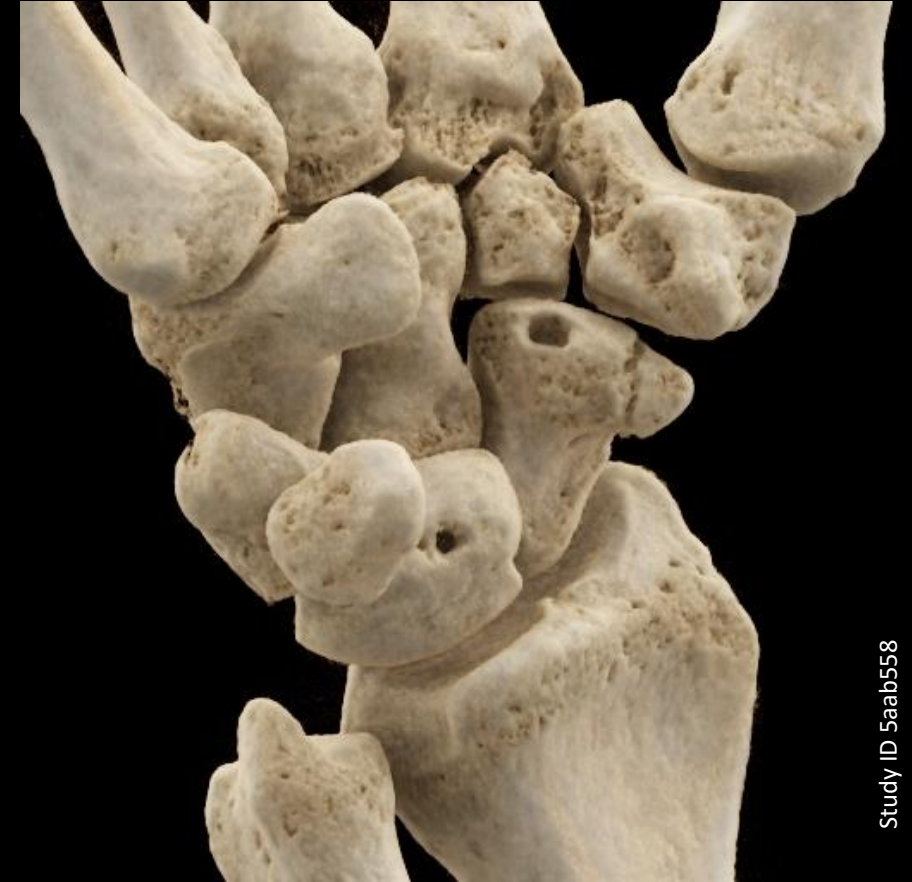
Study ID 5aab558

Image reprocessed on *syngo.via* with cinematic VRT.  
Cinematic VRT is recommended for communication, education,  
and publication purposes and not intended for diagnostic reading.

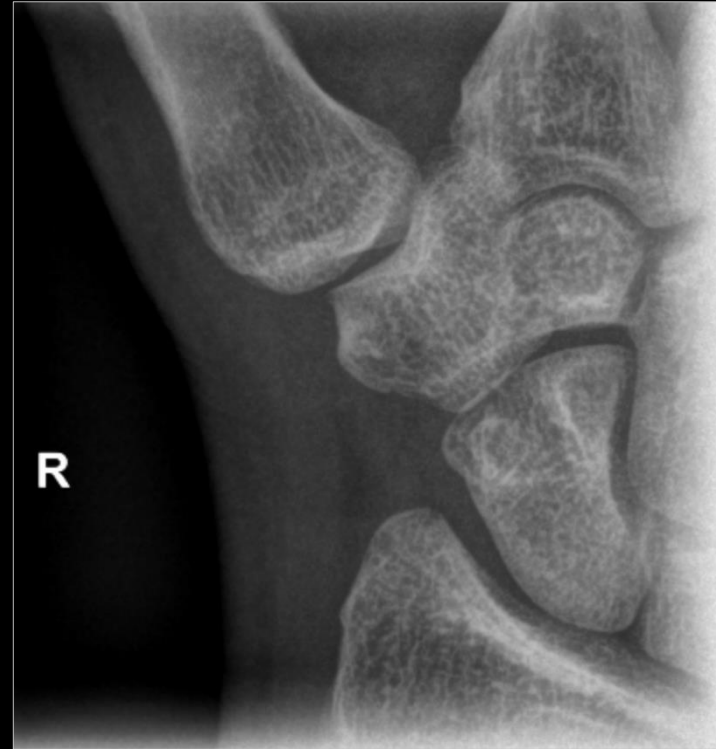
Scaphoid view

Anterior-posterior and lateral radiographs, as well as dedicated scaphoid view fail to display any fracture-related findings.

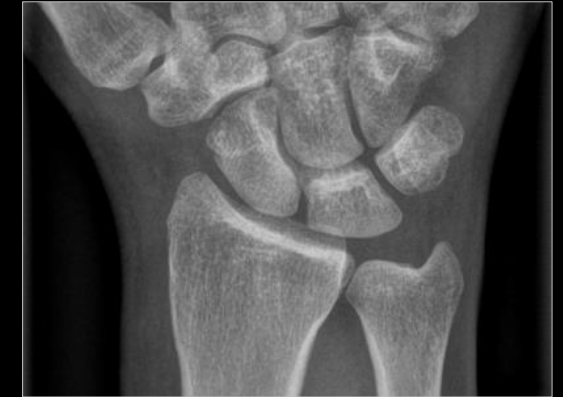
AP

Conventional X-ray examinations

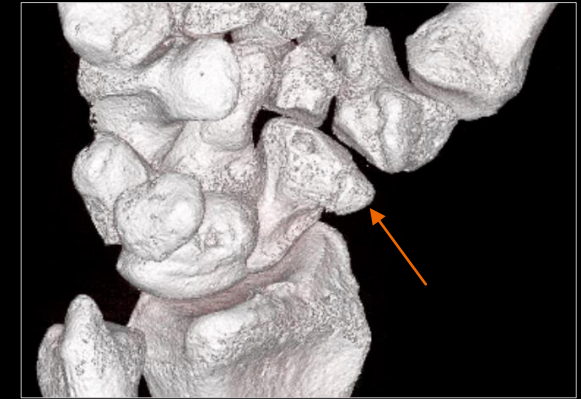
VRT view

Reformatting of Real3D<sup>1</sup> Hi-Res data with respect to the long axis of the scaphoid reveals a subtle, non-displaced fracture of the scaphoid's tubercle.

Tubercle fractures of the scaphoid are usually stable (unlike waist fractures) and do not require surgical treatment. Cast immobilization for six weeks and subsequent physical therapy was recommended. Radiological and clinical follow-up was satisfactory showing good fracture healing.
