Wrist arthrography

Multitom Rax Real3D¹ Hi-Res clinical case University Hospital Wuerzburg, Germany

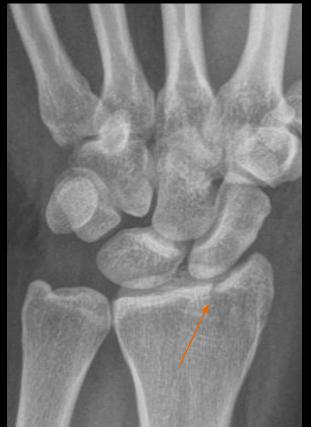
Conventional X-ray examination

In standard radiography, a slightly displaced fracture of the radial styloid process could be ascertained (arrow). Before commencing surgical treatment of this Chauffeur type fracture, trauma surgeons requested pre-operative assessment of scapholunate ligament integrity.

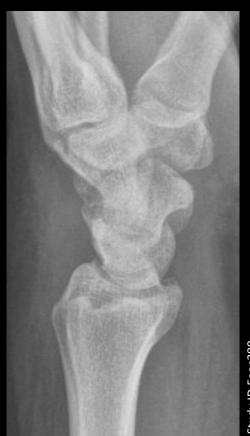
Settings for tableside scan with Standard Protocol

Tube voltage 80 kV

Current time product 197 mAs

Dose area product 118 μGy·m²

Calculated value for CTDI_{vol,32} 1.6 mGy

Scan time 14 sec

Number of projections 318

Pixel size 0.2 mm

Reconstruction kernel very sharp (equivalent to Ur77)

Slice thickness 1 mm

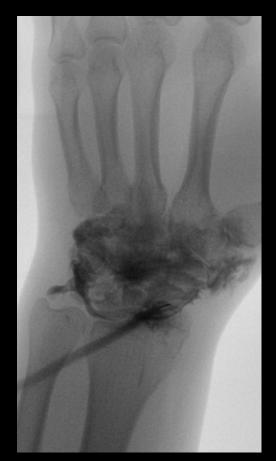
Fluoroscopy-guided injection

Fluoroscopy-guided, two-compartment wrist arthrography (midcarpal, radiocarpal) depicted no communicating lesions of the intrinsic carpal ligaments. Subsequent Real3D imaging visualized the Chauffeur fracture of the distal radius (arrow), while ruling out any discontinuity of the scapholunate interosseous ligament (circle). The patient remained in the same position for fluoroscopy and Real 3D imaging using the tableside scan trajectory for wrist imaging.
