Study protocol

# Fixation of acetabular fracture

Ortho/trauma surgery

CIARTIC Move, VB10A

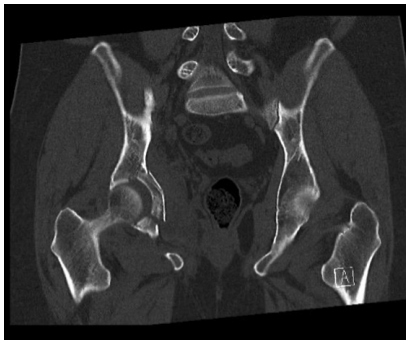
Fig. 1

**Preoperative CT imaging:** acetabular fracture with involvement of the posterior pillar and posterior wall on the right

Acetabular fracture with involvement of the posterior pillar and the posterior wall  
AO classification: 62B2  
(Figs. 1–3)

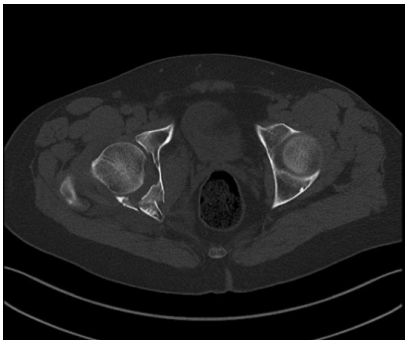
Fig. 2

**Preoperative CT imaging:** acetabular fracture with involvement of the posterior pillar and posterior wall on the right

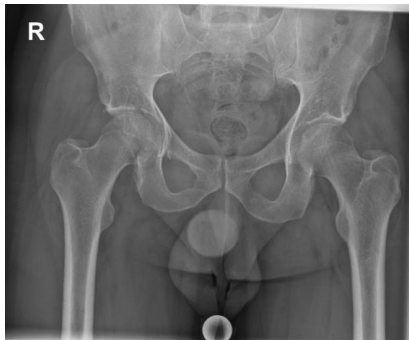
Fig. 3

**Preoperative pelvic overview:** acetabular fracture of the right side

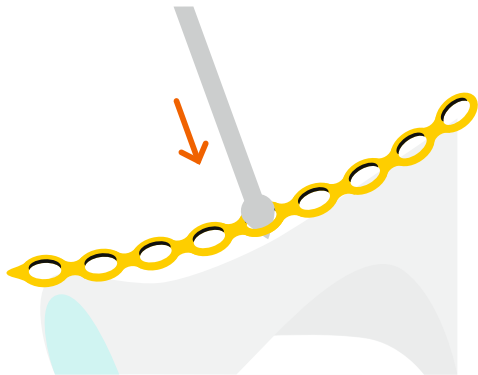
Fig. 6

Contouring the plate to fit the anterior column

Fixation of acetabular fracture: after assessing the fracture using preoperative CT imaging, a pelvic brim plate was contoured to fit the anterior column and then fixated with screws.  
(Figs. 4–11)

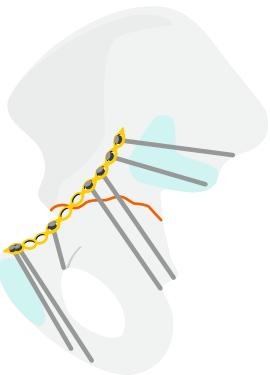
Fig. 7

Fixation using pelvic brim plate

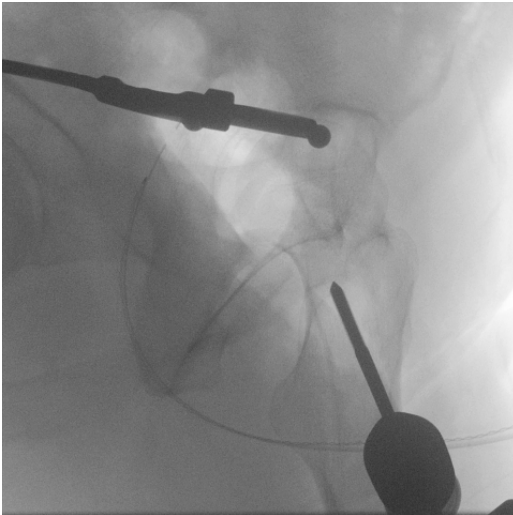
Fig. 8

**Intraoperative image with Schanz screw inserted in the proximal femur:** this provides traction on the femoral head to allow subluxation of the hip joint and subsequent reduction and treatment of the acetabular fracture.

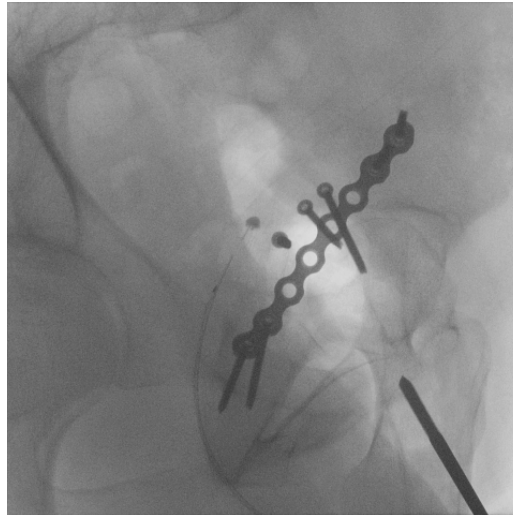
Fig. 9

**Intraoperative image:** access via the Kocher-Langenbeck approach. Low-profile plate inserted along with KF3 lag screws

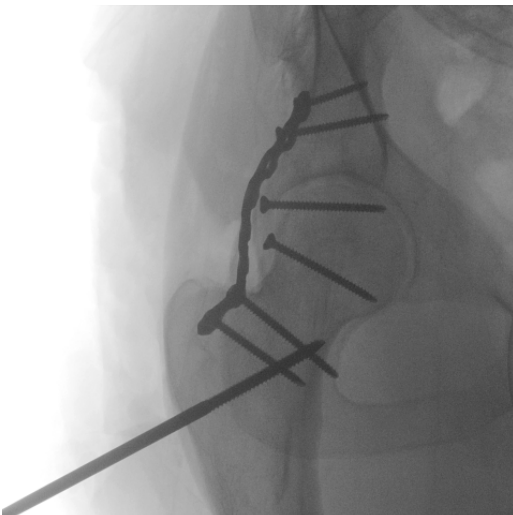
Fig. 10

**Intraoperative check:** correctly inserted plate and screws, correct reduction of the fracture

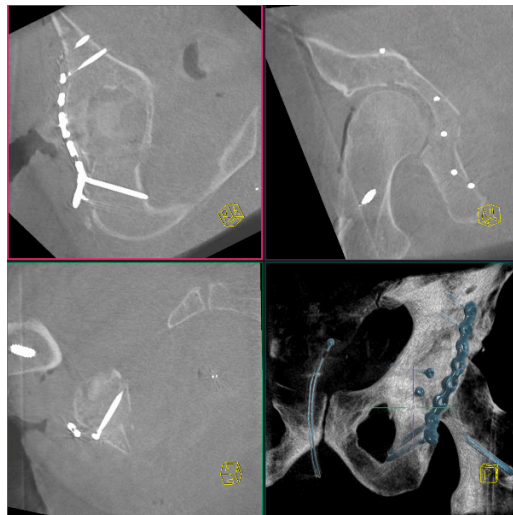
Fig. 11

**Intraoperative 3D scan:** correctly inserted implant, correct screw position, correct reduction of the fracture

**3D imaging** played a vital part in confirming the success of the surgery. The dose area product was 1904.18  $\mu\text{Gy}\cdot\text{m}^2$  and the radiation time was 99.7 seconds.
