Endoleak and stent-graft occlusion after endovascular aneurysm repair

History

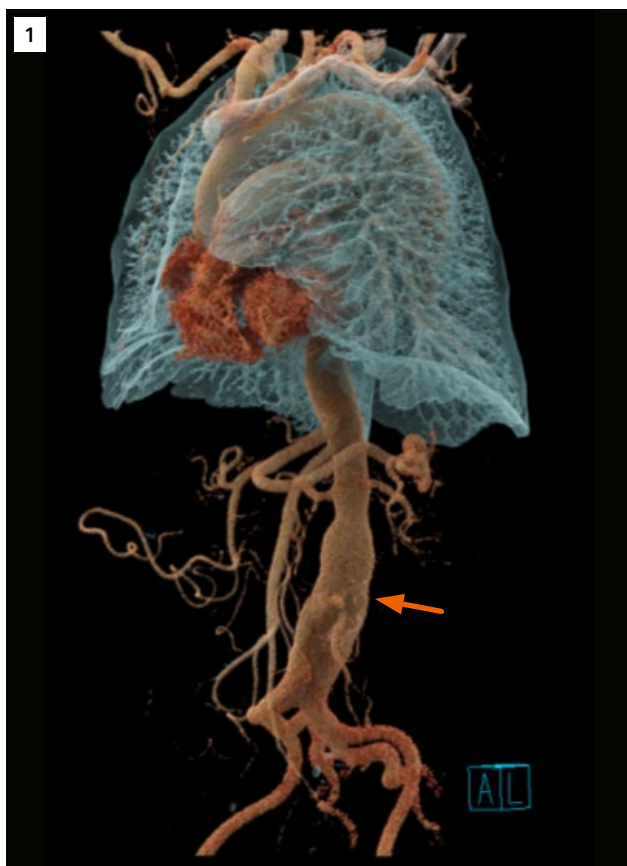
1 A cVRT image shows an infra-renal AAA (arrow) before EVAR. Both common iliac arteries are dilated.

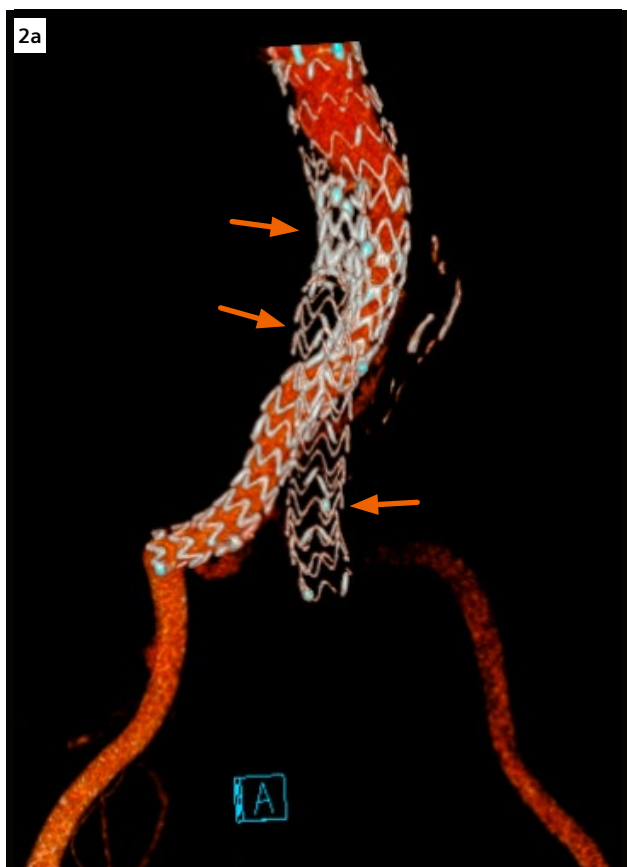
2 cVRT images show a left-anterior view (Fig. 2a) and a right-posterior view (Fig. 2b) of the twisted iliac prostheses. The left iliac prosthesis is occluded showing no blood flow within (arrow, Fig. 2a), and the LEIA (dotted arrow, Fig. 2b) is fed by a type III endoleak (arrows, Fig. 2b).

CTA images showed a bifurcated aortic stent-graft in the aneurysm sac and both common iliac arteries (CIA). The CIA prostheses appeared to be twisted – the left prosthetic leg was attached posteriorly to the right iliac artery and patent, whilst the right prosthetic leg was attached anteriorly to the left iliac artery and occluded. An endoleak (Type III) was visualized posteriorly at the proximal end of the left iliac prosthesis (L3 level), coursing left-posteriorly along the aneurysmal sac, extending behind the occluded left iliac prosthesis and finally feeding the left external iliac artery (LEIA).

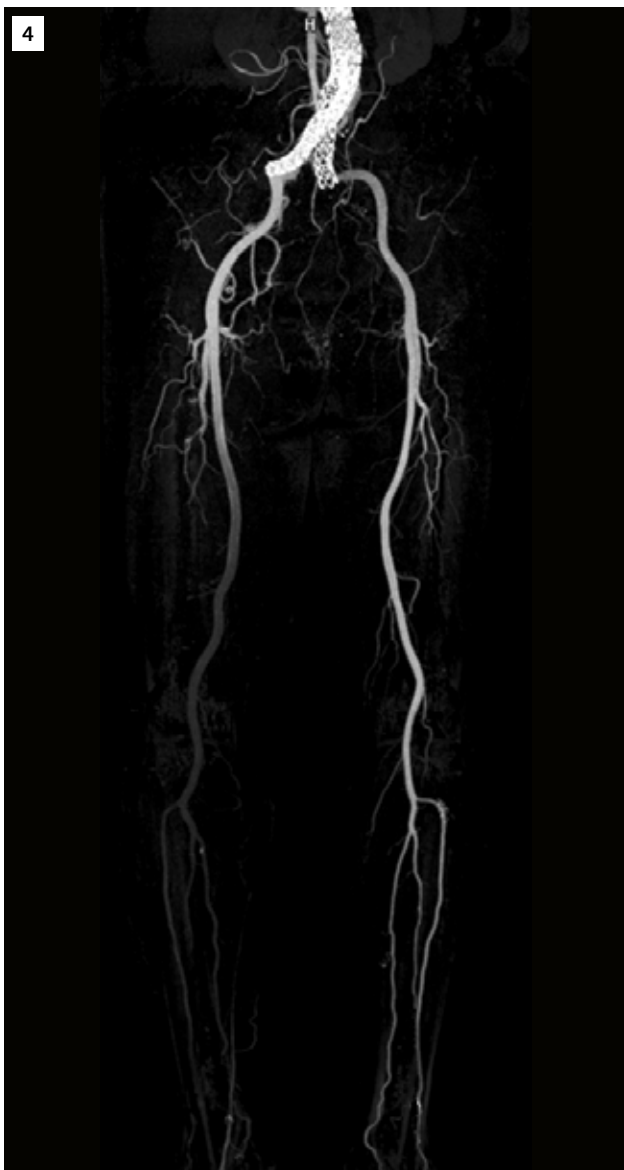
4 A MIP image shows an overview of the runoff CTA. The left iliac prosthesis shows no contrast within; however, the distal arteries in the left lower limb are well-opacified. The contrast of the arteries in the right lower limb appears to be shallow, presumably due to the delay in acquisition timing.

The contrast enhancement of the right lower limb arteries appeared to be shallow, presumably due to the delay in acquisition timing. There were no signs of stenoses or thrombi. Subsequently, the patient was scheduled for endovascular recanalization and repair.
