# Secondary Scaphoid Nonunion

Multitom Rax Real3D¹ Hi-Res clinical case University Hospital Wuerzburg, Germany

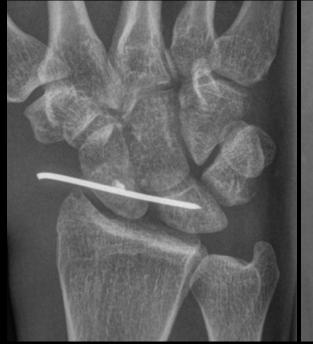
Lateral

Radiography displays dorsal dislocation of the corkscrew anchor in the lateral view (right side; arrow). While transfixation of the scapholunate gap appears satisfactory in AP view (left side), lateral view depicts dorsal extension of the lunate bone suggesting insufficient stability of the scapholunate compartment.

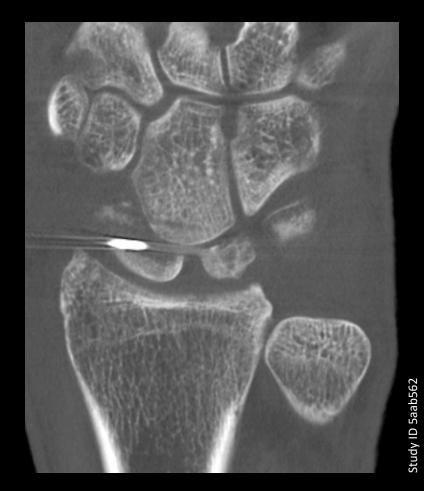
# Multitom Rax Real3D¹ Hi-Res Settings

## **Settings for tableside scan with dedicated Metal Protocol**

*Tube voltage* 116 kV

Current time product 223 mAs

*Dose area product* 315 μGy⋅m²

Calculated value for CTDI<sub>vol,32</sub> 4.7 mGy

Scan time 14 sec

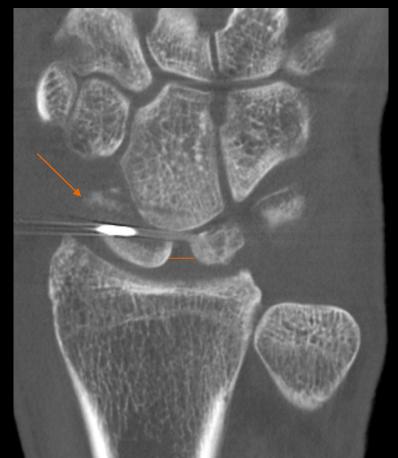
Coronal view

Rax Real3D images with metal artefact reduction also display widening of the scapholunate gap and dorsal intercalated segment instability (DISI) position of the central carpal column, confirming insufficient transfixation. Coronal image shows additional bone resorption in the scaphoid (arrow).
