syngo WARP—Artifact Reduction Techniques Associated with MR Conditional Implants

Theresa Bachschmidt; Ferdinand Lipps, Ph.D.; Mathias Nittka, Ph.D.

Reprint from the customer magazine MAGNETOM Flash, February 2012, Pages 4–5

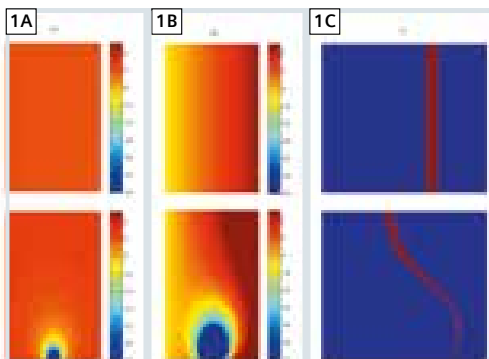
1 The upper row visualizes the ideal case of slice selection, while the lower row displays the effects on the slice selection by a distorted background field: (1A) B_0 field map in slice select direction, (1B) B_0 field map in direction of slice encoding with superimposed magnetic gradient field for excitation, and (1C) position of the excited slice.

- Changes in tissue contrast: Failure of fat suppression and saturation bands.
- In-plane distortion: The local field offset leads to a shift of image pixels in the readout encoding (i.e. frequency encoding) direction.
- Through-plane distortion: The local field offset leads to curved and frayed slices instead of the expected flat image plane (Fig. 1).
