In-stent Restenoses and Occlusion – a follow-up of Multiple Peripheral Arterial Stents

By Pan Liu, MD; Yuquan Wang, MD; Xi Zhao*, MD; Rongpin Wang, MD
Department of Radiology, Guizhou Provincial People’s Hospital, Guiyang, P. R. China
*Siemens Healthineers China

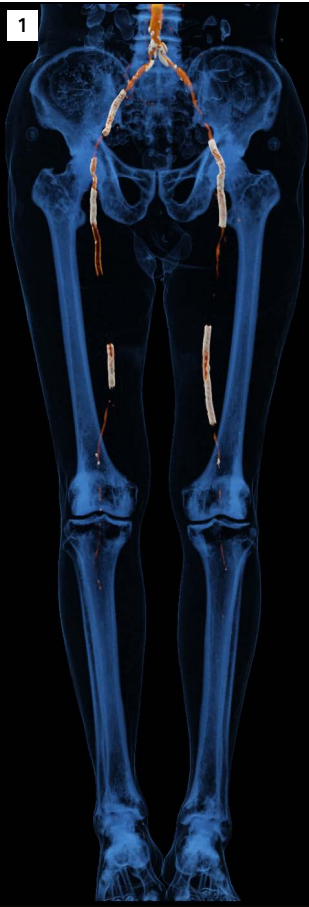
1 A cinematic VRT image shows an overview of bilateral multiple stents. A transparent distal segment of the proximal femoral stent indicates an occlusion.

CTA images showed multiple stents in the right external iliac artery, as well as bilaterally in the proximal and distal femoral arteries. A complete contrast filling defect was seen in the distal segment of the right proximal femoral stent, measuring 5.6 cm in

length, indicating an occlusion. Collateral vessels allowed visualization of the circulation in the lower limb. Various degrees of lumen irregularity and narrowing caused by hypodense areas within the stents were seen in all stents, suggesting in-stent restenoses.

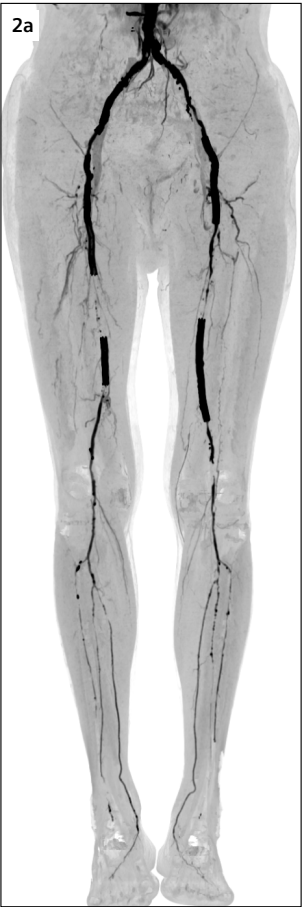
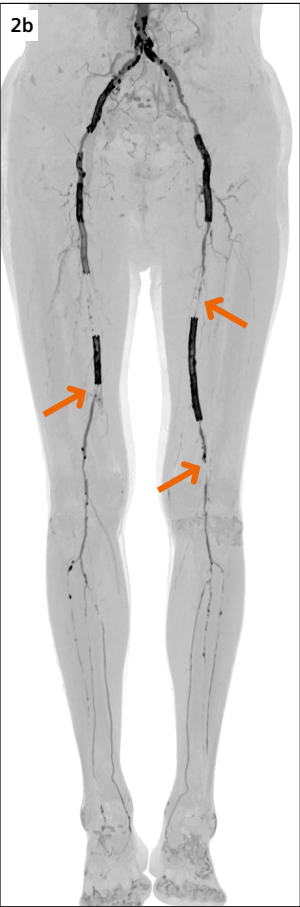
2 Inverted MIP images (Fig. 2a, 45 keV; Fig. 2b, 70 keV; same windowing) demonstrate the DSA-like views. Contrast enhancement is significantly improved showing more vascular details in the image displayed at 45 keV (Fig. 2a). Moderate stenoses bilaterally in the external iliac arteries, as well as severe stenoses (Fig. 2b, arrows) in the middle segment of the left femoral artery, the left popliteal artery and the right femoral artery distal to the distal stent are shown.

Extensive calcified and noncalcified plaques were bilaterally demonstrated. Moderate stenoses bilaterally in the external iliac arteies, as well as severe stenoses in the middle segment of the left femoral artery, the left popliteal artery and the right femoral artery distal to the distal stent were visualized. The patient successfully underwent angioplasty.

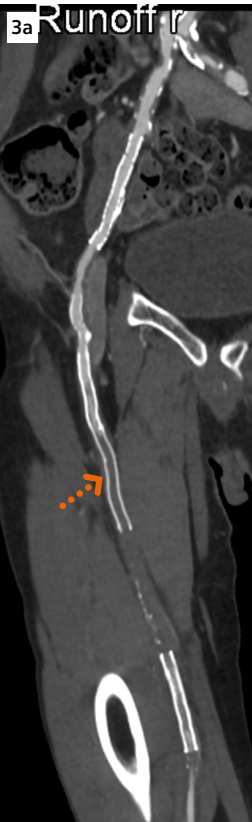
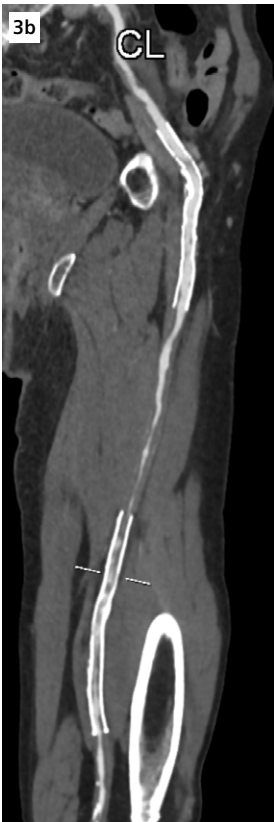
3 Curved MPR images (Fig. 3a, right side; Fig. 3b, left side) show the luminal views of the stents. A complete filling defect of the contrast in the distal segment of the right proximal femoral stent is seen (Fig. 3a, dotted arrow), indicating an occlusion. Various degrees of lumen irregularity and narrowing caused by hypodense areas within the stents are present suggesting in-stent restenoses.
