# Postoperative control after inlay replacement of a knee arthroplasty

Multitom Rax True2scale Body Scan<sup>1</sup> clinical case  
Krankenhaus der Augustinerinnen, Cologne, Germany

# Clinical background and indication for Multitom Rax True2scale Body Scan<sup>1</sup>

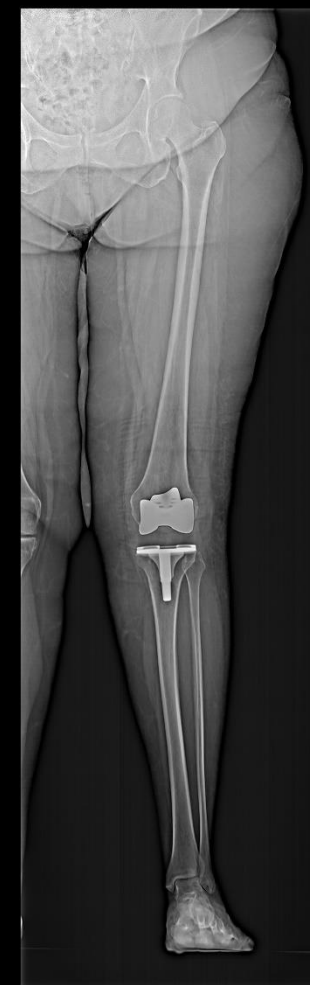
A long leg examination was required for postoperative documentation to evaluate the position of the prosthetic elements.

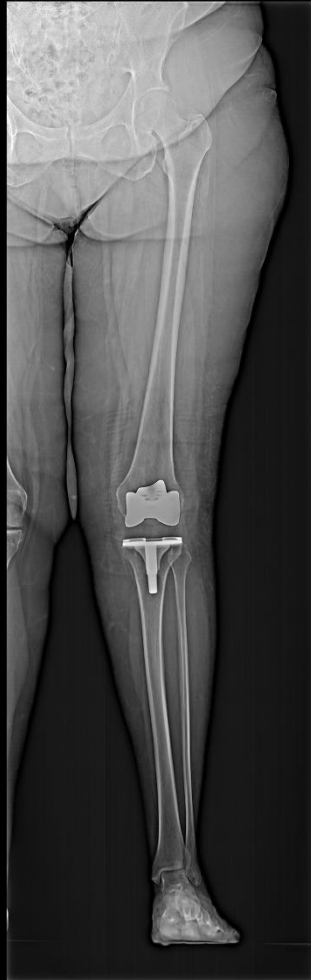
Study ID 5aad078

## True2scale Body Scan in one plane using **upright XL** protocol

*Scan range* 102 cm

*Scan time* 7 sec

*Tube voltage* 117 kV

*Current time product* 462 mAs

*Dose area product* 592  $\mu\text{Gy}\cdot\text{m}^2$

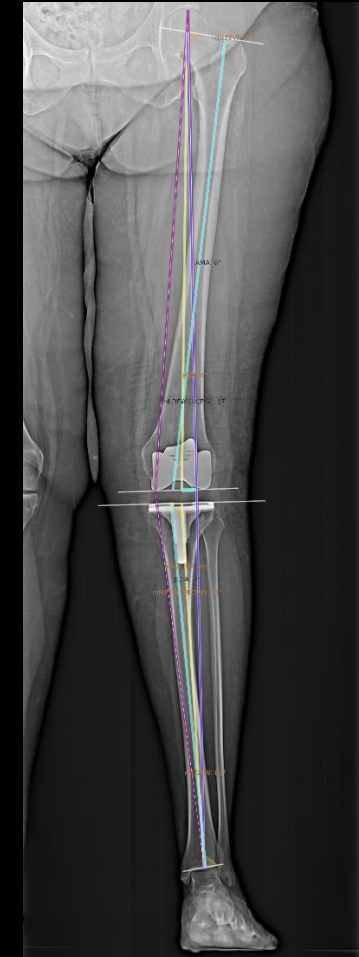
Study ID 5aad078

True2scale Body scan of the full leg was done with the patient in a weight-bearing position. To evaluate postoperative control, the mechanical and anatomical axes of the lower extremity were measured:

- The mechanical axis of the lower extremity corresponds to the purple line from the center of the femoral head to the center of the ankle joint.
- The yellow lines are the femoral mechanical axis, which runs from the head of the femur to the intercondylar notch of the distal femur, and the tibial mechanical axis, which extends from the center of the proximal tibia to the center of the ankle.
- The femoral and tibial anatomical axes are represented by the blue lines.

The measurements showed no abnormalities, so no additional treatment or therapy was needed.
